Manhole Inspection Summary

Manhole # S43AA_030MH

Insp Date: **8/20/08 10:29 AM**

Location Address: **Broadway**

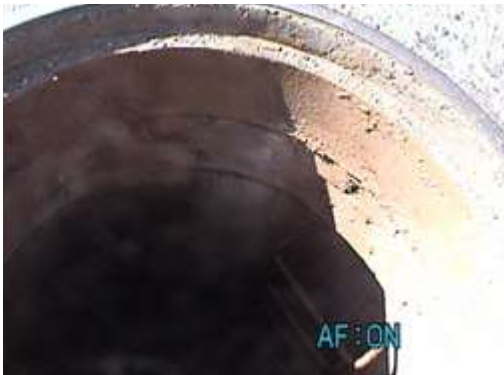
Defect 2

Frame leaks

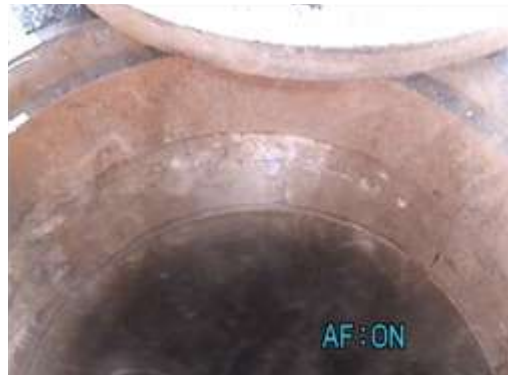
Defect 1

Infiltration: ☐ None ☒ **Joint** ☐ Cracks ☒ **Mortar** ☐ Roots ☐ Wall

Infiltration: ☐ None ☐ Joint ☐ Cracks ☐ Mortar ☐ Roots ☒ **Wall**

Infiltration

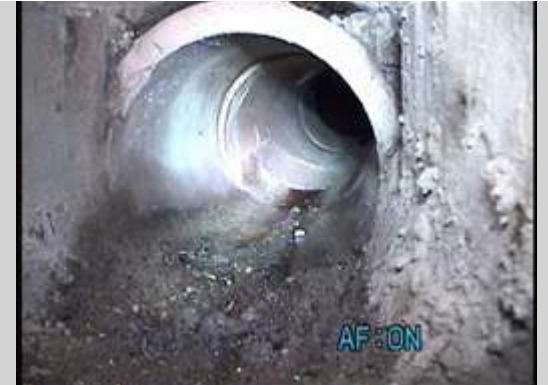
12 O'Clock Outflow

Pipe Height: **8.4** (in.) Rod and Bar (Angled)
Pipe Material: **Clay** ☐ Pipe Lined
Invert Depth: **10.10** (ft.) Flow Characteristics: **None**
Deposits: ☐ None ☐ Mud ☐ Sludge ☒ **Debris** ☐ Grease
Silt Depth: **0.15** (in.) Deposits Extent: **Light**
Infiltration: **None** Pipe Seal Cond: **Sound**

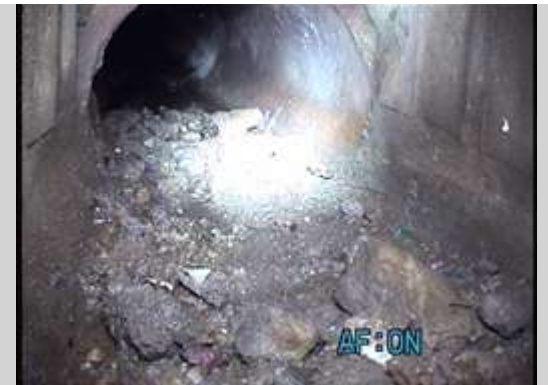
3 O'Clock Inflow

Pipe Height: **8.4** (in.) Rod and Bar (Angled)
Pipe Material: **Clay** ☐ Pipe Lined
Invert Depth: **10.00** (ft.) Flow Characteristics: **None**
Deposits: ☐ None ☐ Mud ☐ Sludge ☒ **Debris** ☐ Grease
Silt Depth: **0.25** (in.) Deposits Extent: **Light**
Infiltration: **None** Pipe Seal Cond: **Sound**
